KENNEBEC RIVER BASIN  
Waterville, Maine

# **RESERVOIR DAM ME 00472**

## **PHASE I INSPECTION REPORT NATIONAL DAM INSPECTION PROGRAM**

SEPTEMBER 1981

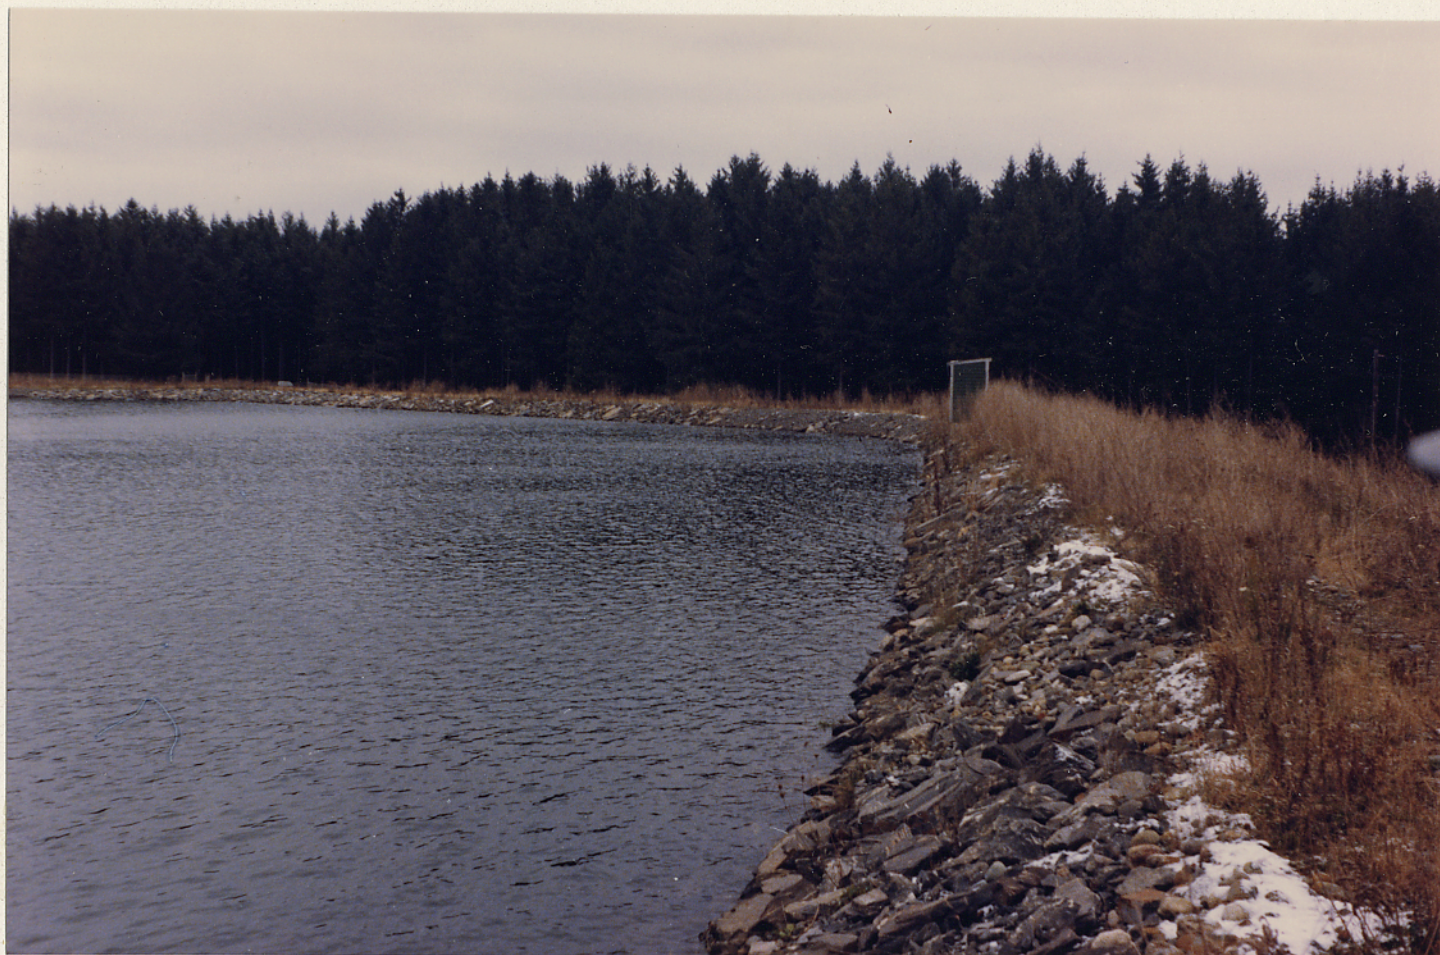
RESERVOIR DAM  
View From Right Abutment

(1) Crest - The embankment crest was true to line with no apparent dips, sags, cracks or other evidence of distress (Photo 1 & Overview). The crest has a well established grass cover with no signs of trespassing.

(2) Upstream slopes - The upstream face was in very good condition with an undamaged rip-rap cover (Photos 1, 2 3 & Overview).

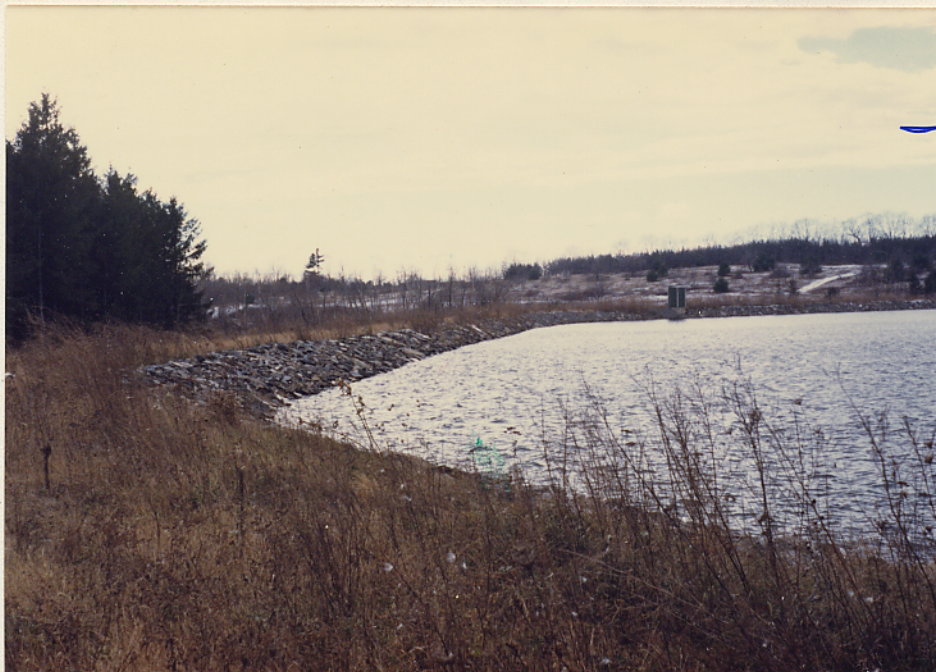
Photo 1

Upstream Face from  
Left Abutment

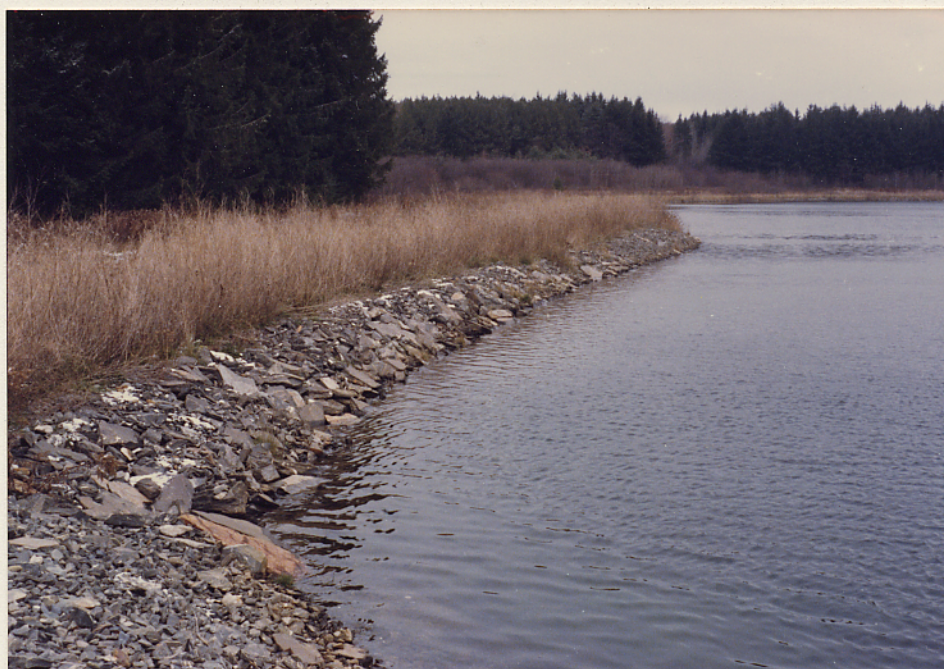
Photo 2

Upstream Right  
Abutment from  
Overflow Structure

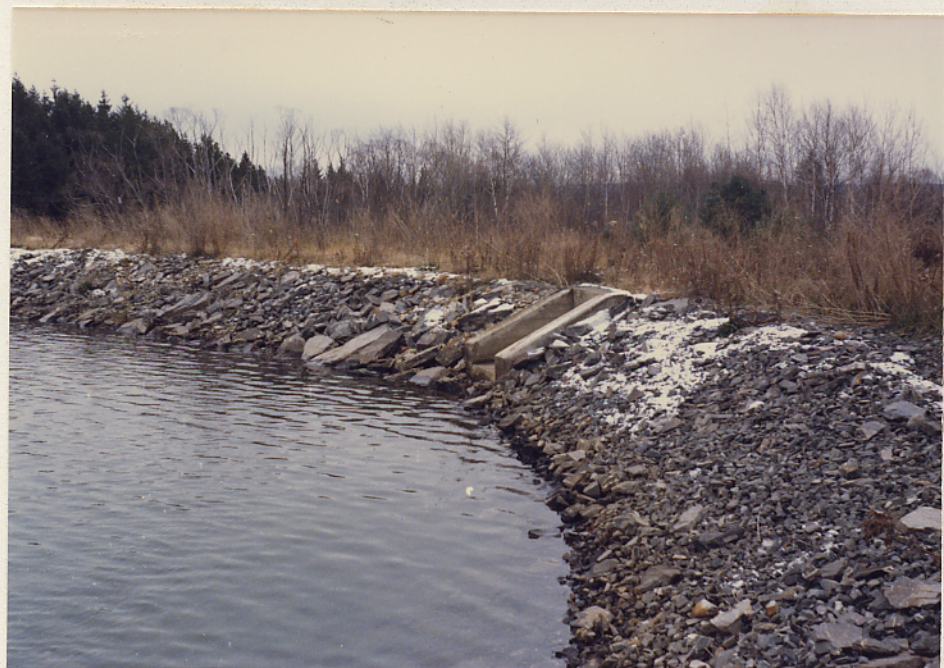
Photo 3

Upstream Right Face  
with Concrete Over-  
flow Structure

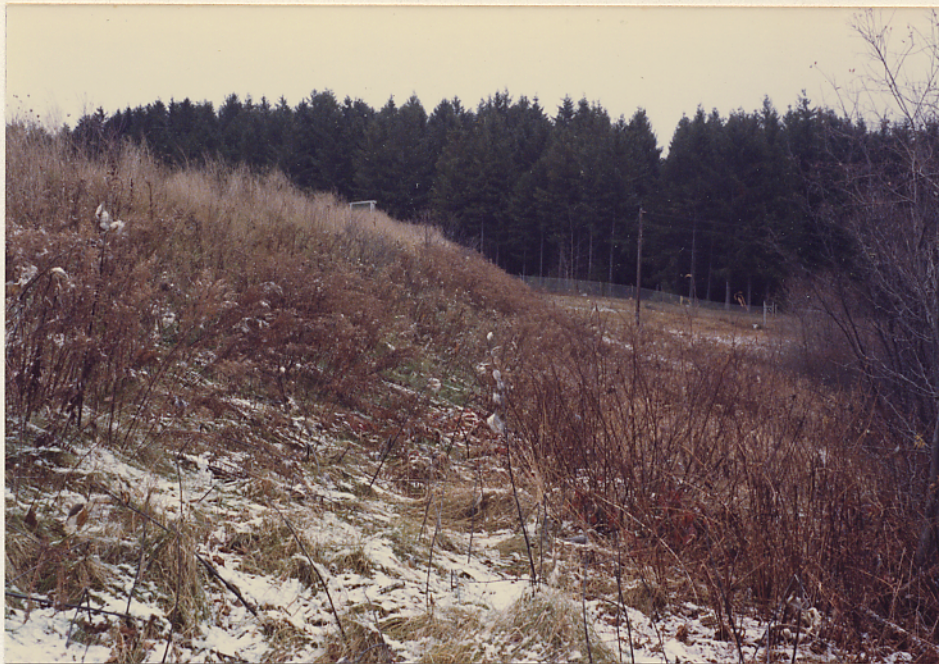
Photo 4

(3) Downstream slope - The downstream slope is dry with a heavy, well established grass cover (Photo 4). The slope showed no signs of lateral movement, erosion, sagging, or slides. No seepage was observed. The grass and weeds appeared overgrown and uncut but in general the slope was in good condition.

Downstream Face  
from Right Side.

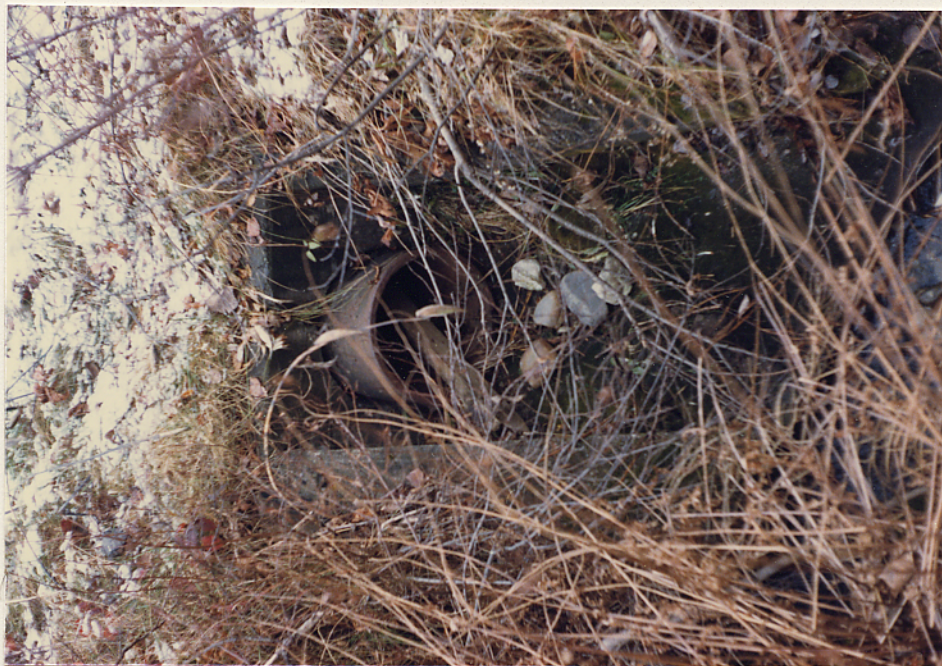
Photo 5

Downstream Outlet  
of 14"  $\varnothing$  Overflow  
Pipe

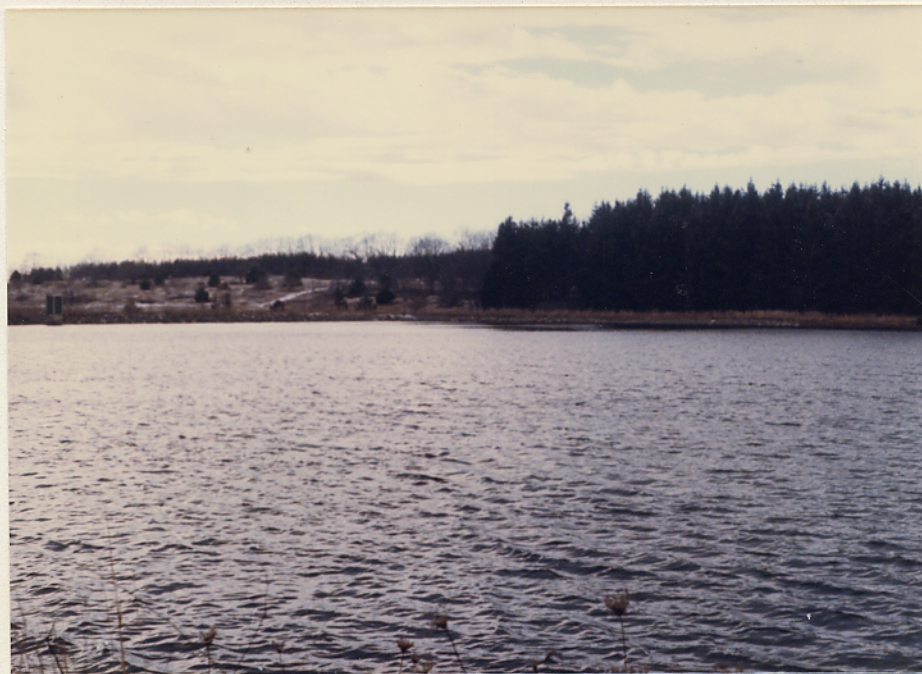
Photo 6

View Across Reservoir  
from Left Side Looking  
Towards Dam.
